# Manhole Inspection Summary

Manhole # S25E\_\_058MH

Insp Date: **7/24/08 3:54 PM**

**Location** Address: **227 CAREY ST**

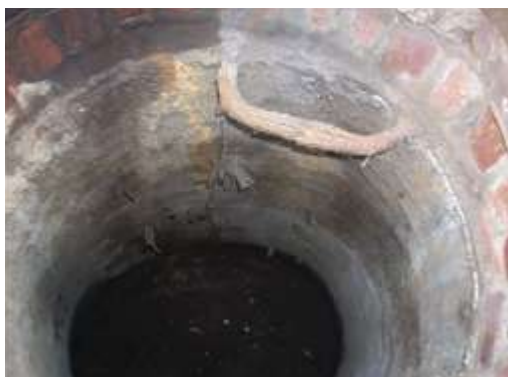
Defect 5

Count: **1** Missing: **4** ☒ **Corroded**

CORRODED AND MISSING STEPS

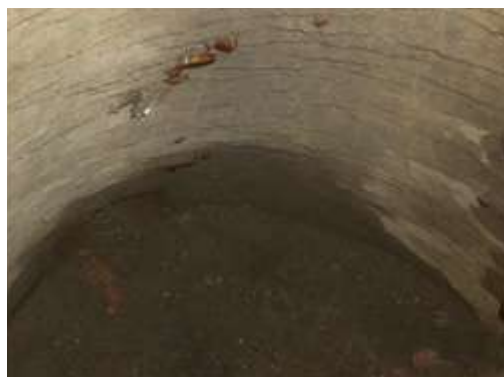
Defect 4

Infiltration: ☐ None ☐ Joint ☐ Cracks ☐ Mortar ☐ Roots ☒ **Wall**

INFILTRATION OF BARREL

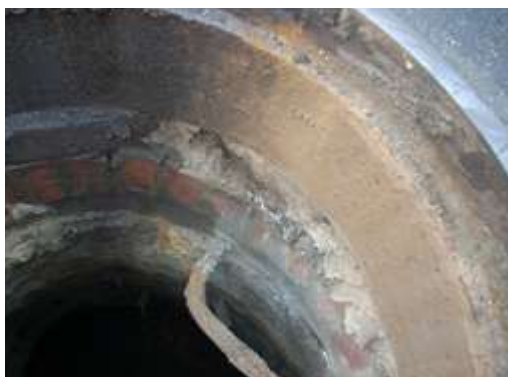
Defect 3

Offset: **2** (in.)

Condition: ☐ Sound ☒ **Cracked** ☐ Root Intrusion ☐ Loose Brick ☒ **Deteriorated**

FRAME OFFSET AND DETERIORATED CHIMNEY

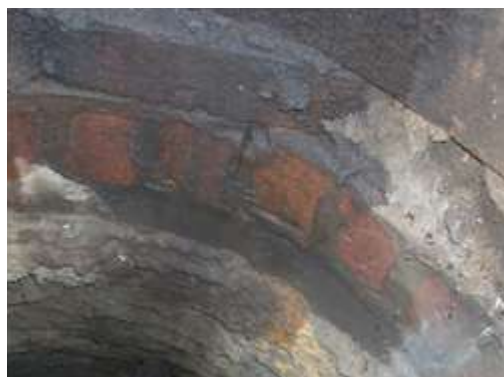
Defect 2

CRACKED CHIMNEY

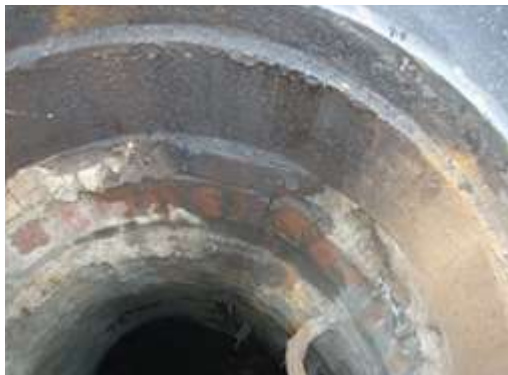
### Defect 1

Infiltration: ☐ None ☒ **Joint** ☐ Cracks ☐ Mortar ☐ Roots ☐ Wall

INFILTRATION OF JOINT
